Thermomodernization of Historical Buildings with Residential Facades

Dariusz Bajno*

UTP University of Science and Technology, Bydgoszcz, Poland

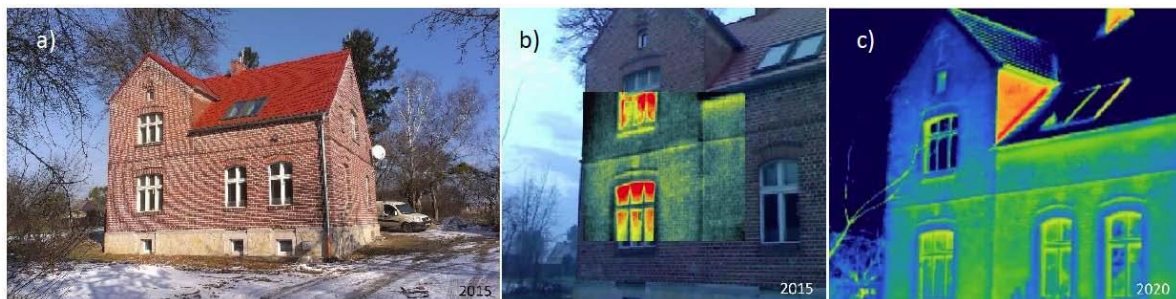
Figure 1: Southern elevation of a 90-year-old residential building: **a)** view, **b)** thermal image 2015 (outside temp. -3°C), **c)** thermal image 2020 (outside temp. -3°C).

insulation (Figures 8-15). These differences can already be clearly seen on the building facades Fig. 1(b and c). Before thermo-modernization, the temperature level of internal wall surfaces has been in scope of +10,5°C to +13°C (Figures 2-4).

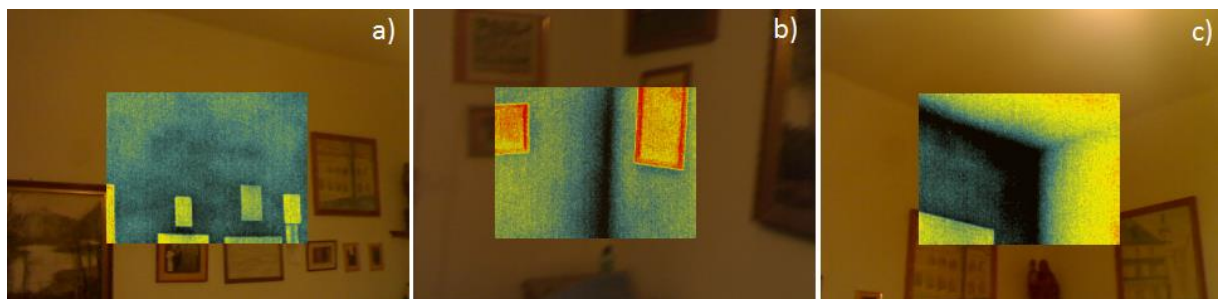
Figure 2: Thermovision map of uninsulated and wet ground floor walls: **a)** flat walls, **b)** 2D corner, **c)** 3D corner - closed from the top by a floor ceiling.

Radiographic examinations were carried out at an external ambient temperature of -3°C and an internal building temperature of +16°C to +18°C. Calculations were made using Physibel Trisco 13.0 showed that if the outside temperature falls down to -20°C and inside the building remains + 20 °C (on $\varphi \approx 45\%$), moisture could appear on the surface of wall: $t_i = -7,5^\circ\text{C} < t_s = +7,7^\circ\text{C}$ (dew point temperature), temperature coefficient $F_{Rsi} \ll 0.72$ [7,13], (Figure 5). This would create very favorable conditions for the development of mold fungi (Figure 2) [3,4,8,10].

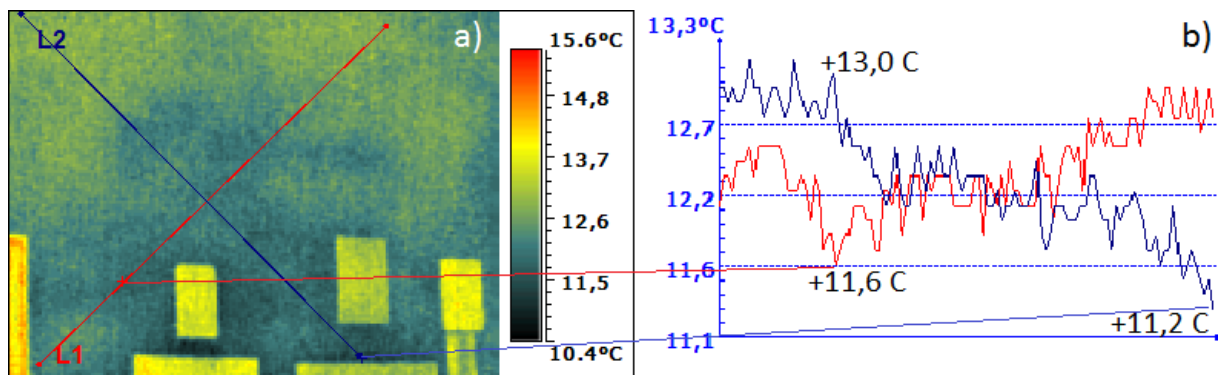
The graphic image of temperature distribution in the wall shown in Figure 2a has been supplemented with temperature distribution lines (Figure 3). It clearly indicates the heterogeneous thermal resistance of the wall, and thus its irregular surface and inside moisturizing (darker fields).

Figure 3: Insulated internal wall: a) thermal image, b) temperature distribution graph along lines L1 and L2.

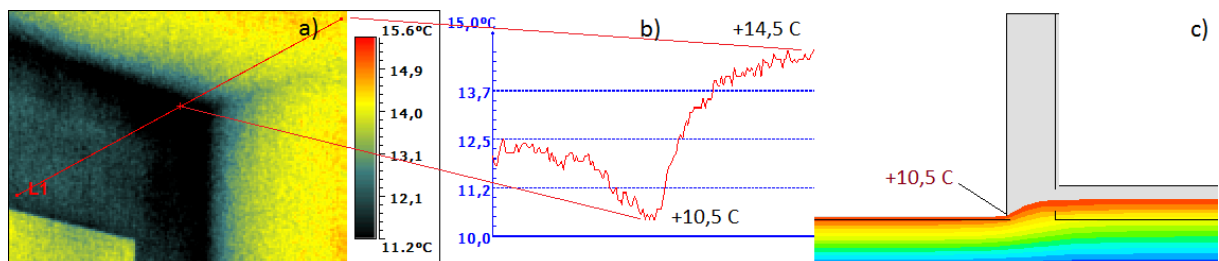
A similar situation is presented in the thermovision image and temperature diagram in Figure 4. The calculations performed, simulating the existing

condition, confirmed the possibility of lowering the temperature to +10,5°C in the inner corner of the room, which would further lead to the appearance of a further drop in the outside temperature moisture on its internal surface (Figure 5).

Figure 4: Corner of the ground floor walls: a) thermovision image, b) graph of temperature distribution along the L1 line, c) size of the corner temperature determined based on the calculation model.

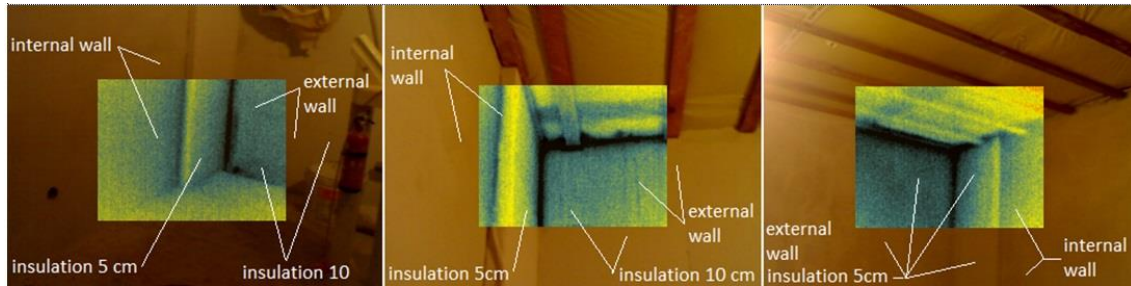
Figure 6: Thermal image of floor walls insulated with diffusion-open, mineral Multipor panels of the thicknesses given in the photographs above.

A computational analysis of the previous and current situation, taking into account the occurrence of a linear thermal bridge in insulation (Figures 6,7) confirms here a manufacturing defect, revealed as a break in thermal insulation. This defect has been removed. The calculations indicated the validity of the thermomodernization, although it was carried out on the inside of the partitions, i.e. from the "center". It significantly improved their heat protection parameters, although it did not meet the statutory requirements. One of the two main disadvantages of using the so-called insulation from the "inside" is to reduce the floor space of the rooms, while the second possibility of frost and corrosion damage related to moisture condensation inside the partitions and limited possibilities of its evaporation. This applies to, inter alia endings of wooden ceiling beams in historical buildings [1]. This problem will be discussed in the next article. The thermal parameters of partitions before and after thermomodernization are presented in Table 1.

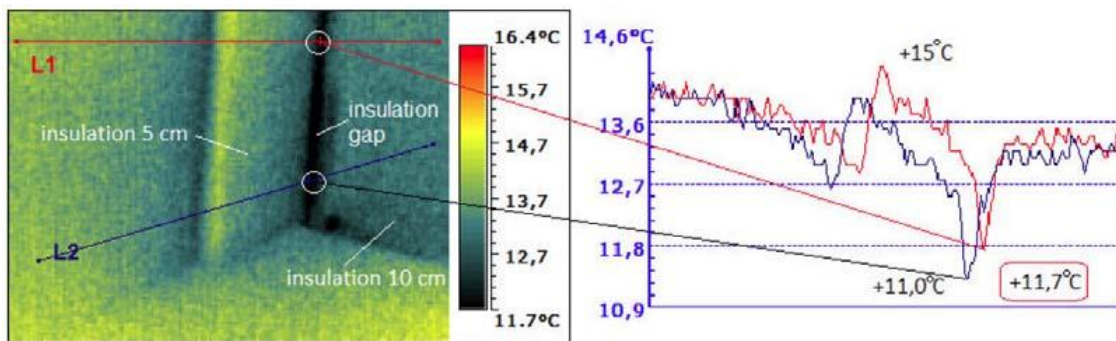
Figure 7: Diagram of temperature distribution at the interface between insulated external and internal walls.

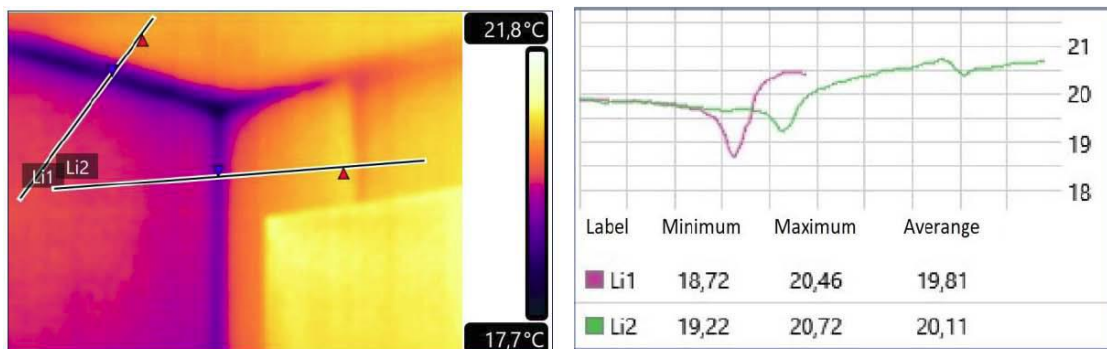
The following diagram (Figure 10) presents a thermovision image of the temperature distribution at the contact point of walls insulated from the inside, shown in Figure (9, right side of the internal wall). The temperature drops in the inner corner by approx. 1°C is clearly noticeable in comparison to the remaining wall surfaces. It should be considered that the test result is very similar to the results of calculations (Figure 9), despite the fact that the calculations have

used the indoor air temperature equal $+20^\circ\text{C}$, and in fact it was 1°C to 2°C higher.

Figure 10: Current thermovision image of the inner wall corner - right side (Figure 9) after 5 years of operation (outside temp. -3°C, internal temp. +21°C).

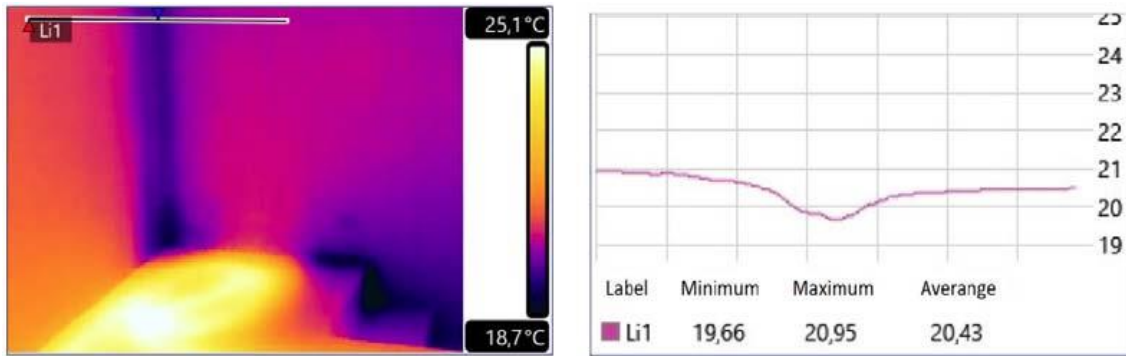
The next thermal image (Figure 11) also shows a decrease in temperature in the corner by about 1°C in relation to the remaining wall surface. In Figure 9 this concave corner is described at a temperature of $+17^\circ\text{C}$, which is 2°C lower than thermovision indications. In fact, this may indicate that the defect in the gap between mineral plates has been filled with a material with similar heat protection parameters (Figure 7), hence the same temperature level of the corner was obtained as on the other side of the inner wall.

Figure 11: Current thermovision image of the inner wall corner - left side (Figure 9) after 5 years of operation (outside temp. -3°C, internal temp. +21°C).

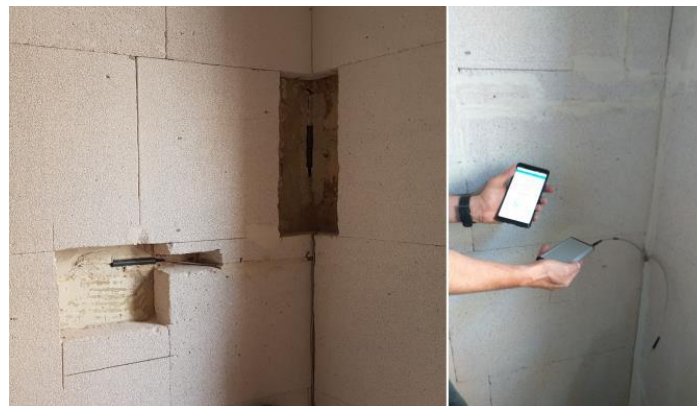
Figure 21: Monitoring of moisture content in permanently covered layers of partitions.

After the thermomodernization of the object, the technical condition of its partitions should be monitored [2,8], verifying this assessment, inter alia thermal imaging tests, in situ humidity measurement, for example by permanently embedded probes inside of

them (Figure 21). The author has already used this method in one of the historic buildings where he has been monitoring the temperature and moisture level of the adhesive layer for three years, between the historic brick wall and the diffusion-open insulation layer laid on the inside surface of the outer walls (Figure 21).
