Published by Avanti Publishers
**International Journal of Architectural
Engineering Technology**

Tracing the Historical Development of Architecture in Cyprus and its Resilience to Seismic Hazards

Article Type: Research Article

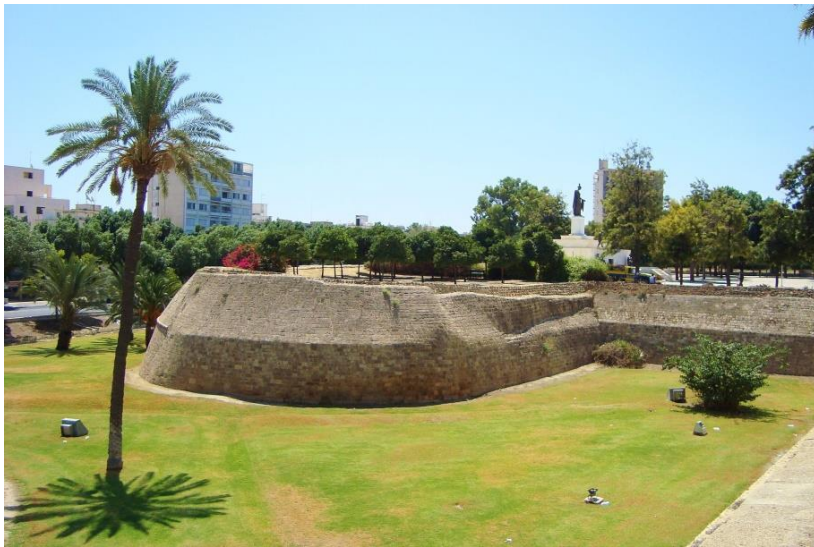
Figure 1: The Venetian Walls of Nicosia (source, A. Savin own work).

The Venetian Walls of Nicosia (Fig. 1) are a series of defensive walls that surround the old city of Nicosia, the capital of Cyprus. The walls are considered to be one of the finest examples of Renaissance military architecture in the Eastern Mediterranean region. The Venetian Walls of Nicosia are characterized by their imposing size and strength. The walls are up to 20 meters high and are made of stone, with bastions and towers strategically placed along their length. The walls are almost 5 kilometers long and have three gates: the Paphos Gate in the west, the Famagusta Gate in the east, and the Kyrenia Gate in the north. The walls are built in a polygonal shape, following the contours of the ground. This means that the walls have a series of angles and bends, which makes it more difficult for attackers to approach them directly. The walls are also reinforced with various defensive features, such as moats, glacis, and ravelins, which further strengthen their defensive capabilities.

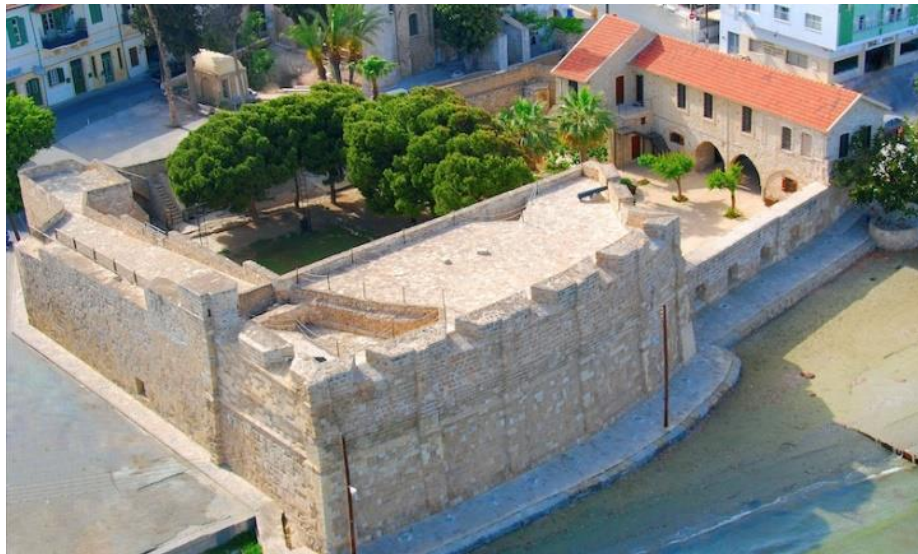
Figure 2: Larnaca Castle [17].

Larnaca's Castle (Fig. 2), also known as Larnaca Fort, is a medieval castle located on the southern coast of Cyprus [17]. The castle is characterized by its sturdy, rectangular structure, which is built from limestone blocks. The walls of the castle are up to 2.5 meters thick, and the entire structure is surrounded by a moat, which was once filled with sea water. The castle has two floors, with a central courtyard that is surrounded by various rooms and halls.

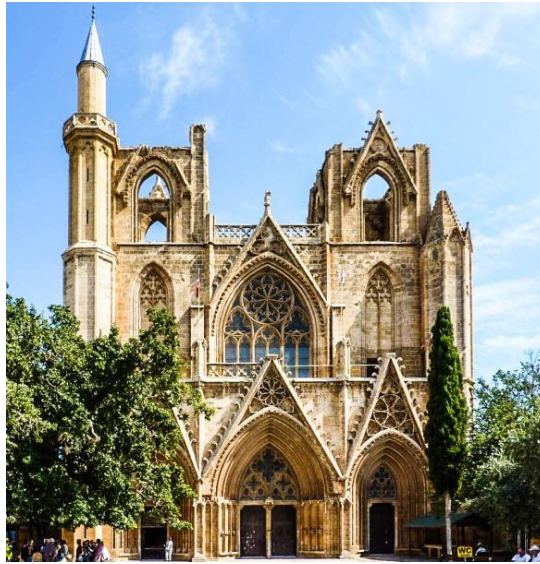
Figure 3: Church of St. Nicholas in Famagusta [18].

The Church of St. Nicholas (Fig. 3) is a medieval church located in Famagusta, a historic city on the eastern coast of Cyprus [18]. The church was built in the 14th century and is considered to be one of the finest examples of Gothic architecture on the island. The church is characterized by its tall, slender proportions and its intricate decorative features. The exterior of the church is built from local limestone blocks and is decorated with a variety of Gothic motifs, including pointed arches, tracery, and quatrefoil shapes. One of the most distinctive features of the Church of St. Nicholas is its bell tower, which is located at the front of the church. The bell tower is octagonal in

shape and is topped with a pointed spire. The tower is decorated with a variety of ornate carvings and has several openings for the bells.

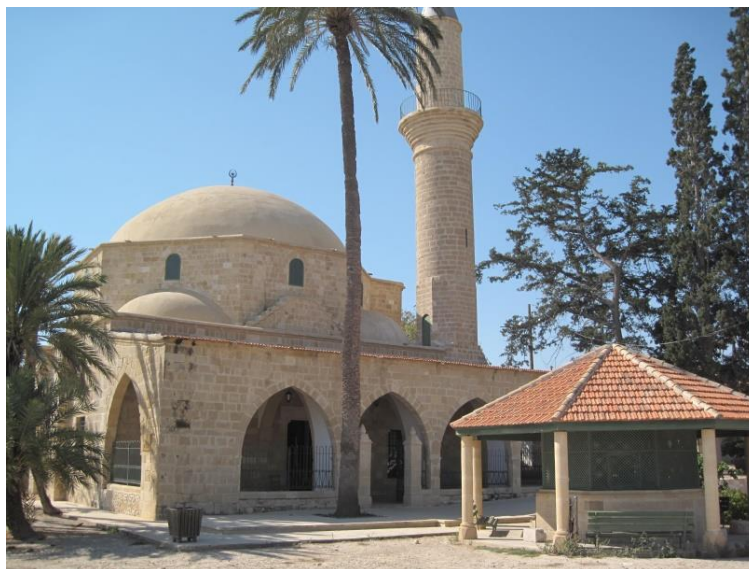
Hala Sultan Tekke (Fig. 4) is a historic mosque located in the city of Larnaca, Cyprus [19]. The mosque is built on the west bank of Larnaca Salt Lake and is considered one of the most important holy places in the Islamic world. The mosque is built on a rectangular foundation made of local stone and its walls are made of thick stone blocks and have no windows. This is because Islamic tradition prohibits the depiction of living beings in religious buildings. The building has a central dome, which is larger than the four smaller domes located at each corner of the building. The domes are made of brick and covered with red tiles. The interior of the mosque is supported by columns made of stone. The columns are arranged in a square pattern around the central dome. The mosque has a large rectangular courtyard, which is surrounded by a low wall. The courtyard is paved with stones and is used for prayer and other religious activities.

Figure 4: The mosque has a large rectangular courtyard, which is surrounded by a low wall. The courtyard is paved with stones and is used for prayer and other religious activities [19].

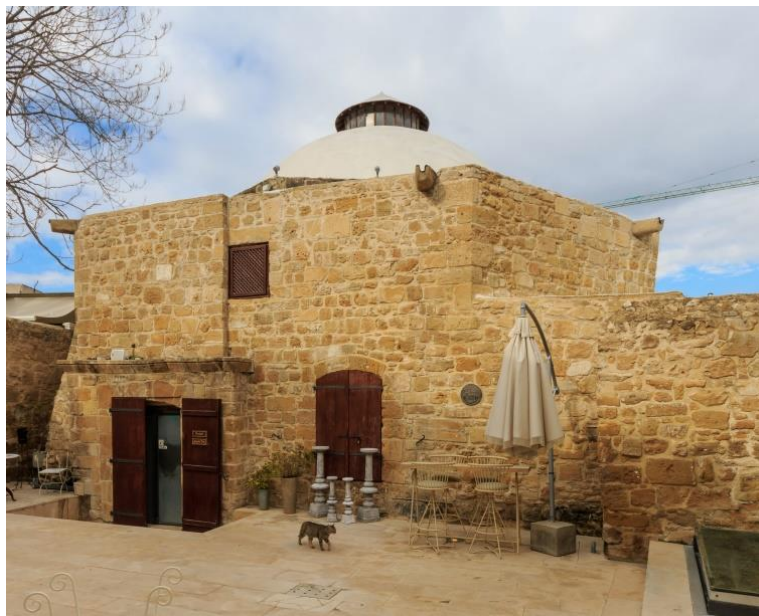
Figure 5: Hamam Omerye, Nicosia (source, A. Savin own work).

Hamam Omerye (Fig. 5) is a historical public bathhouse located in the old city of Nicosia, Cyprus [20]. It was built during the Ottoman era in the 16th century and has since been renovated and restored multiple times. The hamam has many structural characteristics that are unique and distinctive. It is primarily constructed of stone masonry, which is a durable and sturdy building material. The Hamam Omerye has several barrel-vaulted ceilings, which are created by curving a series of arches. The barrel-vaulted ceilings provide structural support and help distribute the weight of the building. The roof is supported by timber roof trusses, which are triangular-shaped structures, made of wood. The timber roof trusses help distribute the weight of the roof and provide structural stability. The walls are reinforced with buttresses, which are projecting support structures that help distribute the weight of the walls and the roof. The Hamam Omerye has several stone columns that support the vaulted ceilings. The columns are constructed of stone blocks, which are stacked on top of one another and held together with mortar. It has several arched openings, which are created by curving a series of stones or bricks. The arched openings help distribute the weight of the walls and provide structural stability and inside it has an underground cistern that collects rainwater. The cistern is constructed of stone and is reinforced with arches and buttresses.

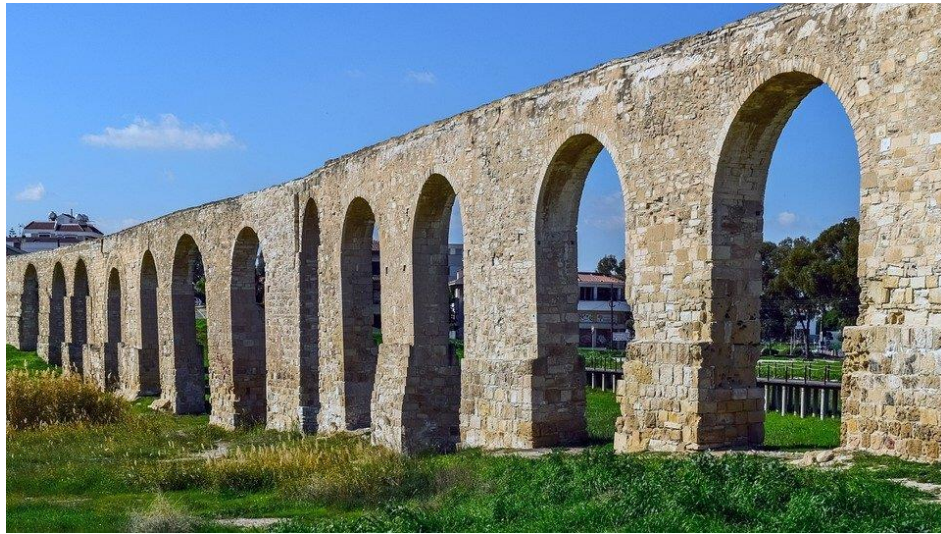
Figure 6: Kamares Aqueduct, Larnaka (source, A. Savin own work).

The Kamares Aqueduct, also known as the Bekir Pasha Aqueduct (Fig. 6), is a historic structure in Larnaca, Cyprus that was built in the 18th century [21]. It was designed to bring water to the city from a nearby spring and is considered a remarkable engineering feat of the time. The aqueduct is constructed of a series of arches, which are curved structures that support the weight of the aqueduct and distribute the water flow evenly. The arches are constructed of brick and are arranged in a linear pattern. The arches are supported by cut-stone piers, which are vertical columns of stone that provide structural support and stability. The piers are spaced evenly along the length of the aqueduct and are constructed of the same type of stone as the arches. The arches and piers are held together with mortar, which is a type of cement that is used to bond the bricks and stones together. The aqueduct features a stone channel that runs along the top of the arches. This channel was designed to carry the water from the spring to the city and is wide enough to allow for easy maintenance and repair. The aqueduct has a stone parapet, which is a low wall that runs along the top of the arches. The parapet is designed to provide additional stability to the aqueduct and to prevent people from falling off the structure. At the end of the aqueduct, there is a water basin that was used to collect the water from the spring. The basin is constructed of stone and is designed to hold a large volume of water.

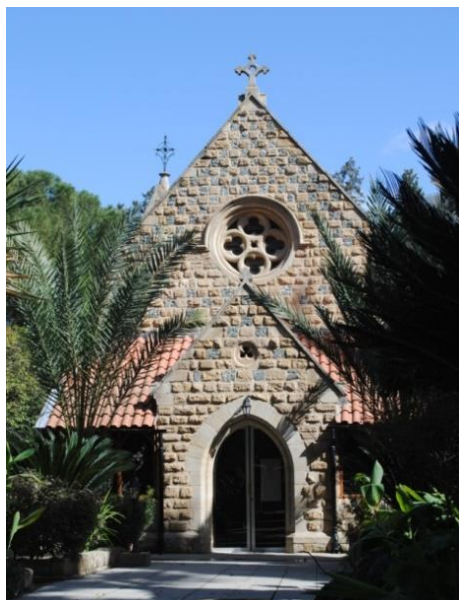
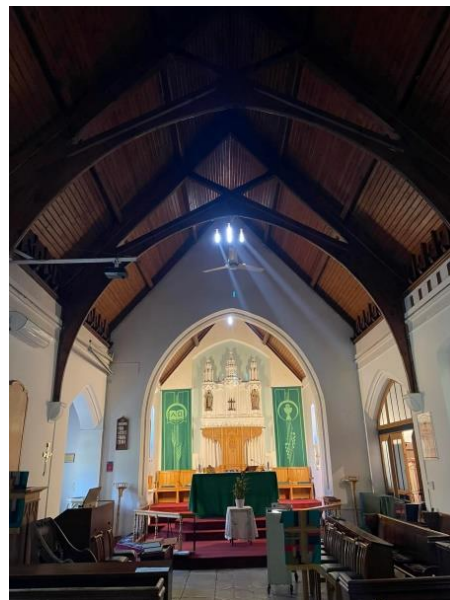
Figure 7: St. Paul's Anglican Cathedral, Nicosia [22].

The cathedral was designed by the British architect William Henry Woodrow and built between 1882 and 1893, during the period of British colonial rule in Cyprus [22]. The design of the church reflects the neo-Gothic style that was popular in Britain at the time, with pointed arches, stained glass windows, and a vaulted ceiling. St. Paul's Anglican Cathedral (Fig. 7) in Nicosia was built using a combination of traditional and modern construction techniques. The walls of the cathedral are constructed using load-bearing masonry, which provides stability and support for the roof and other structural elements. The walls are made of local limestone and are several feet thick in some places. The roof of the cathedral is supported by a timber structure, consisting of large timber trusses and purlins. The roof structure is designed to provide strength and stability to the roof, while also allowing for some flexibility to accommodate movement during earthquakes. The interior of the cathedral features a high vaulted ceiling, which is supported by stone arches and ribbed vaults. The vaulted ceiling provides additional strength and stability to the roof structure, while also creating a sense of grandeur and space within the interior. The cathedral's foundation is constructed using reinforced concrete, which provides additional strength and stability to the building. The foundation is designed to resist the forces of earthquakes and other natural disasters.

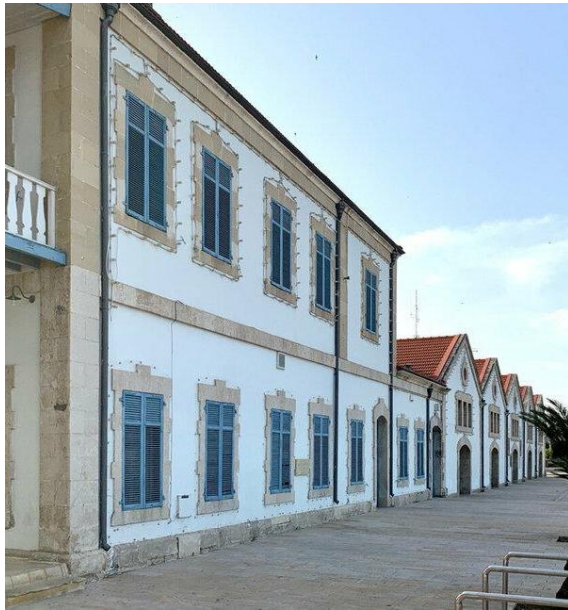
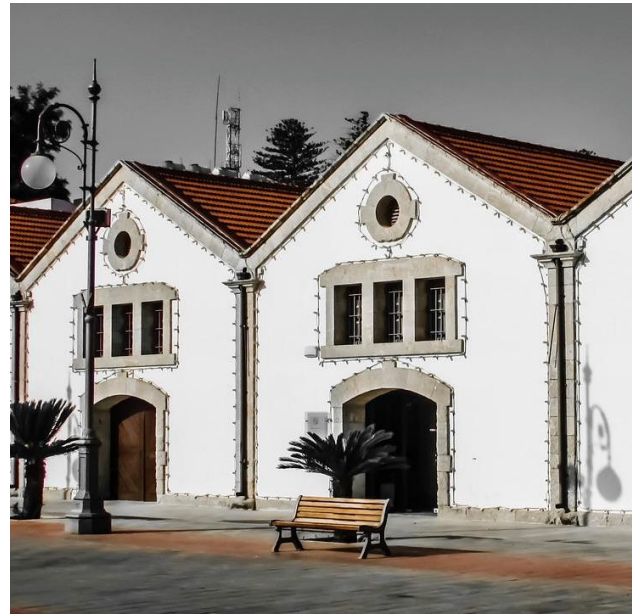
Figure 8: Municipal Art Gallery and Museum of Paleontology, Larnaca [23].

The Municipal Art Gallery and Museum of Paleontology (Fig. 8) is a historic building located in the city of Larnaca, Cyprus. The building was constructed around 1881 during the period of British colonial rule and was originally used as a government building [23]. The aforementioned, it is a masonry building, which means its structural elements are made primarily of stone and brick. The load-bearing masonry walls are the most significant structural element of the building, providing support and stability to the floors and roof. The exterior walls are constructed of local limestone, which is a durable and commonly used material in Cyprus. The walls are several feet thick in some places and are designed to resist lateral loads and provide structural stability. The roof of the building is a traditional pitched roof, covered with terracotta tiles laid in a herringbone pattern which is supported by timber trusses, which span between the load-bearing walls. Inside the building, the most significant structural element is the central staircase, which is made of marble and features decorative detailing. The staircase is supported by load-bearing walls and reinforced with steel elements to provide additional stability.

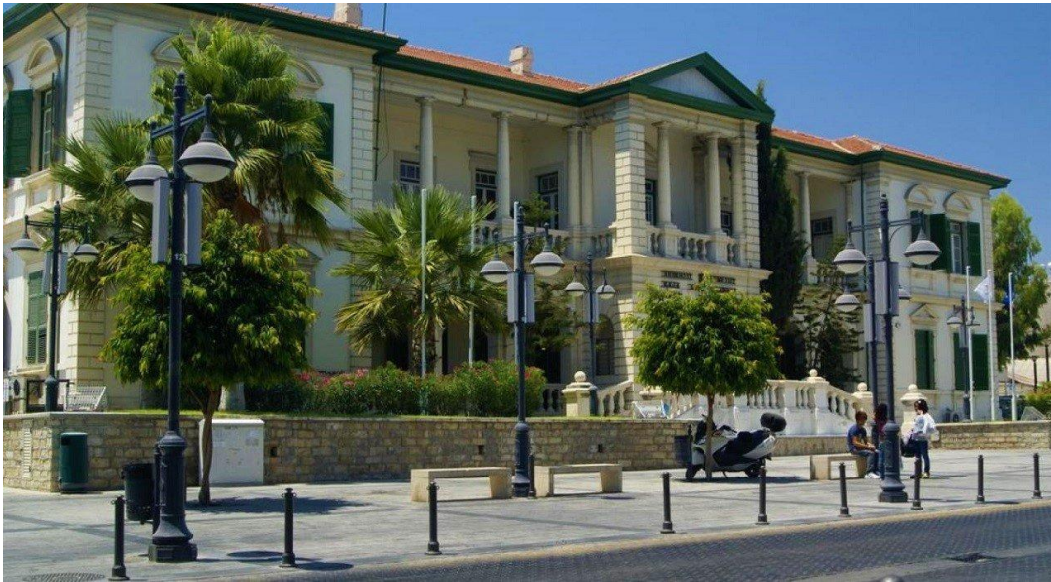
Figure 9: Administration Offices, Limassol [24].

The District Administration Offices in Limassol (Fig. 9) is a mid-century modernist building constructed in the 1960s [24]. The building's structural elements are primarily made of reinforced concrete, which was a popular construction material during the period of its construction. The building's structural design features a series of concrete columns and beams that support the floors and roof. The columns are arranged in a regular grid, creating a rhythm that is consistent throughout the building. The building's floor slabs are made of precast concrete panels that are supported by the concrete beams. The roof of the building is flat and is supported by a series of concrete beams, which span between the columns. The roof is covered with a waterproof membrane, which helps to protect the building from the elements. The District Administration Offices in Limassol are a prime example of mid-century modernist architecture, with a focus on functionality, efficiency, and simplicity. The building's use of reinforced concrete and precast concrete panels allowed for fast and efficient construction.

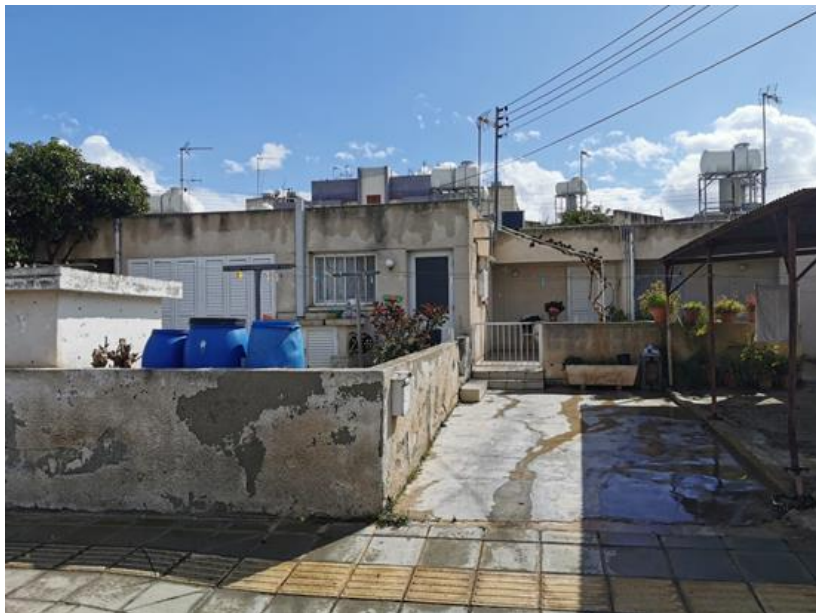
Figure 10: Typical residential refugee house (source, G. Xekalakis own work).

The residential refugee houses in Cyprus (Fig. 10) in 1974 were characterized by their makeshift nature and lack of amenities. They were typically organized into small rooms or cubicles that were partitioned off using plywood or other materials. This type of building was usually constructed with walls that supported the weight of the roof and upper floors and rarely from columns and beams of low-strength concrete.

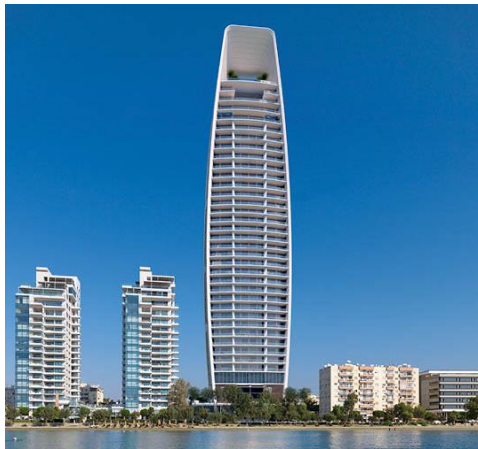
Figure 11: One, Limassol [25].

The “One” is a high-rise building in Limassol (Fig. 11), Cyprus that was completed in 2021. It has a height of around 170 meters, which makes one of the tallest buildings in Cyprus and one of the tallest buildings in the eastern Mediterranean region. The One has a reinforced concrete structure, with a combination of concrete columns, beams, slabs, and a raft foundation with piles because of its position close to the Limassol's coast providing support and stability.

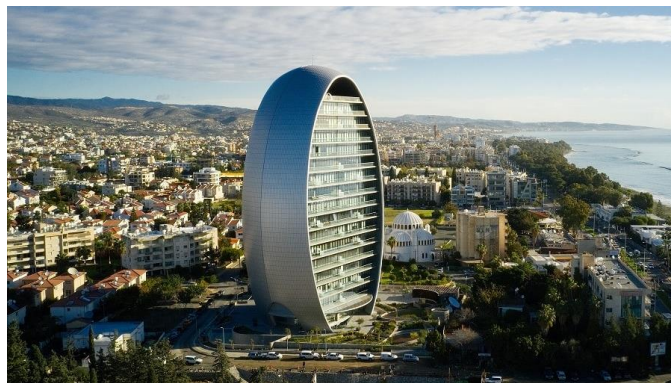
Figure 12: The Oval, Limassol [26].

The Limassol Oval is a high-rise building in Limassol (Fig. 12), Cyprus, which was completed in 2013 [26]. It has a height of around 80 meters and 16 floors. The Limassol Oval is notable for its distinctive elliptical shape, which gives the building a sleek and modern appearance.

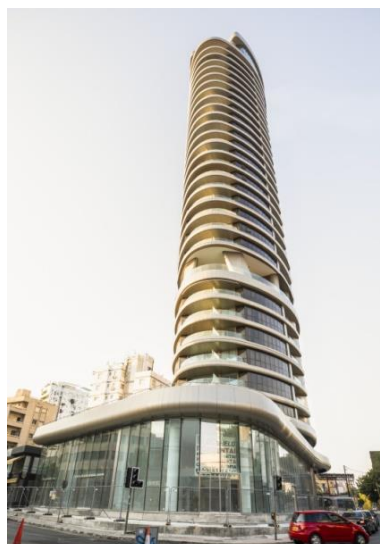
Figure 13: 360 Nicosia [28].

The 360 Nicosia Tower (Fig. 13) is located in Nicosia [27]. With a height of 135 meters and 34 floors, it is one of the tallest buildings in Cyprus. All the above three structures have been constructed using reinforced concrete and they have been designed to meet the relevant building codes and standards, including the seismic design requirements of Eurocode 8.
