The Important Role of Diagnostics for the Structural Recovery of Historic Buildings

Alessandro Grazzini*

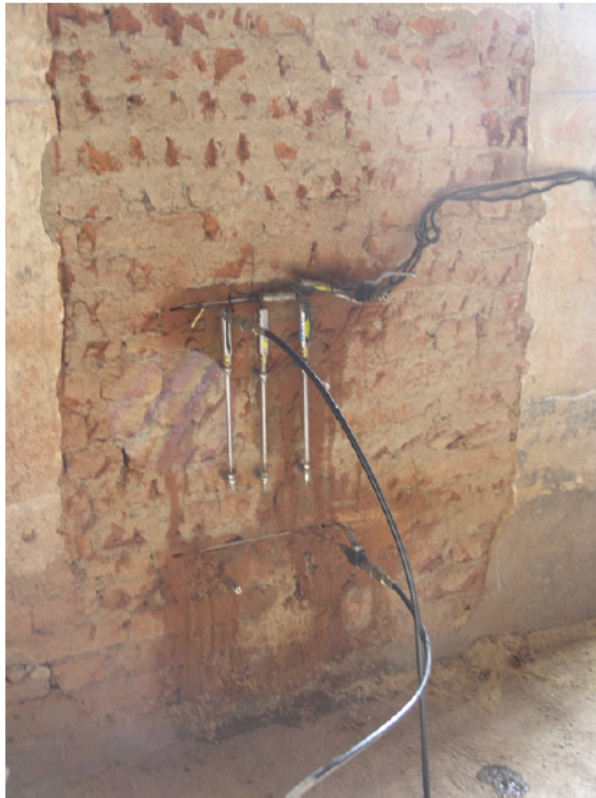
Figure 4: Flat jacks test carried out at the Royal Palace of Venaria.

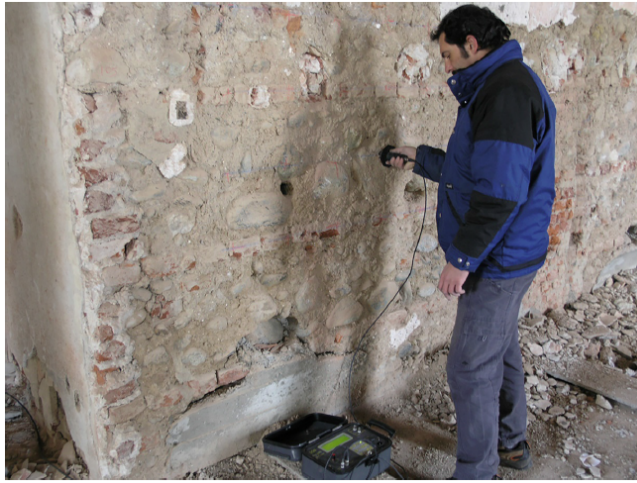
Figure 5: Sonic tests carried out at the Royal Palace of Venaria.
