Thermomodernization of Historical Buildings with Residential Facades

Dariusz Bajno*

UTP University of Science and Technology, Bydgoszcz, Poland

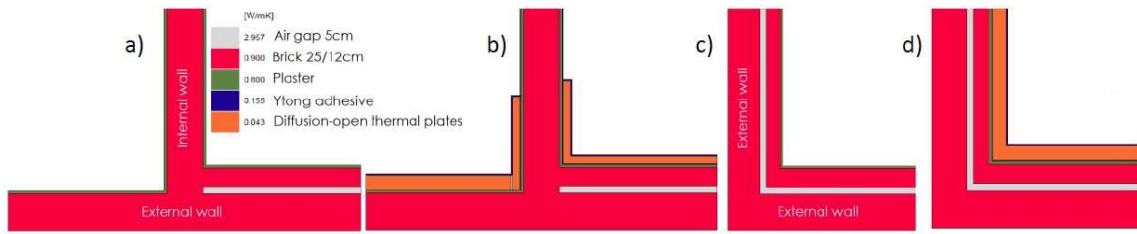
condition, confirmed the possibility of lowering the temperature to +10,5°C in the inner corner of the room, which would further lead to the appearance of a further drop in the outside temperature moisture on its internal surface (Figure 5).

Figure 5: Current model of the outer partition: horizontal cross-section by connecting the gable wall with the inner one: a), c) not insulated, b), d) after thermo-modernization.

The diagrams below show and compare the simulation of the temperature distribution in cross-sections of walls in their original condition (Figure 8) and after the thermomodernization (Figures 9,11,13). Calculations were made for two partition locations: in the corner (Figure 5c,5d), and connection of the outer layered and homogeneous structured-wall with the inner wall (Figure 5a,5b).

As mentioned above, in 2015 building was under the renovation works, and at the same time it was insulated by the inside by the diffusion-open panels, 5 and 10 cm thick, in locations shown in Figures (5b,5d,6,7). Because, during the renovation works, an additional portion of technological moisture appeared in the walls, hence immediately after laying the mineral boards, their thermal resistance did not reach the required level yet. It was visible in the concave corners, where the temperature fall was about 4 °C in comparison to other flat surfaces. This condition could have been the result of a mismatch between the contacting mineral plates of thermal insulation boards, or the result of filling the gap between them, using supplementary material that was still moist/wet.

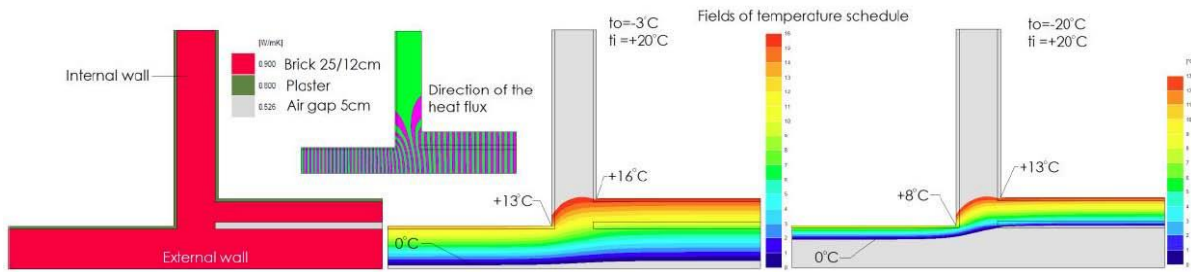
Figure 8 shows the temperature distribution in the outer wall before the thermomodernization, while Figure 9 includes a 5-year service life.

Figure 8: Model and computational simulation of temperature isotherms distribution and adiabat of heat fluxes in building envelope (without insulation) after 5 years of operation (outside temp. to -3°C and -20°C, internal temp. +20°C).

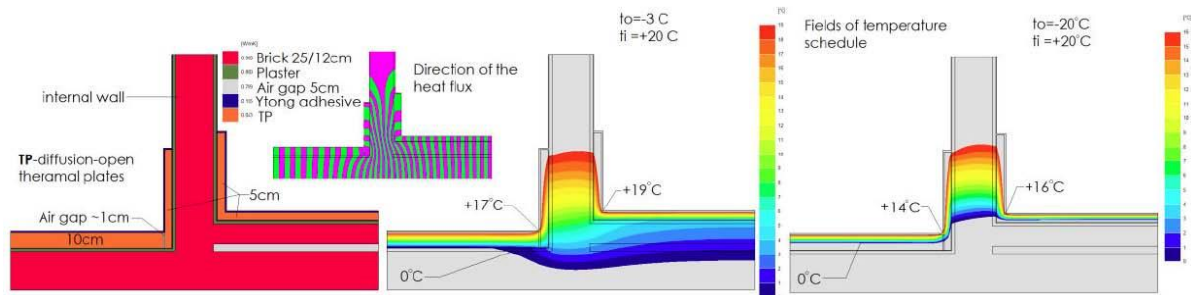
Figure 9: Model and calculation simulation of temperature isotherm distribution and adiabat of heat fluxes in external building envelope after insulation with 5 and 10 cm thick Multipor mineral boards (outside temp. to -3°C and -20°C, internal temp. +20°C).

Comparing the results of calculations presented in Figures 8 and 9, a favorable temperature increase of $\Delta t = +3^\circ\text{C}$ to $+6^\circ\text{C}$ is noticed. These calculations were verified by thermovision testing of the abovementioned corners, which are shown in Figures 10-12.

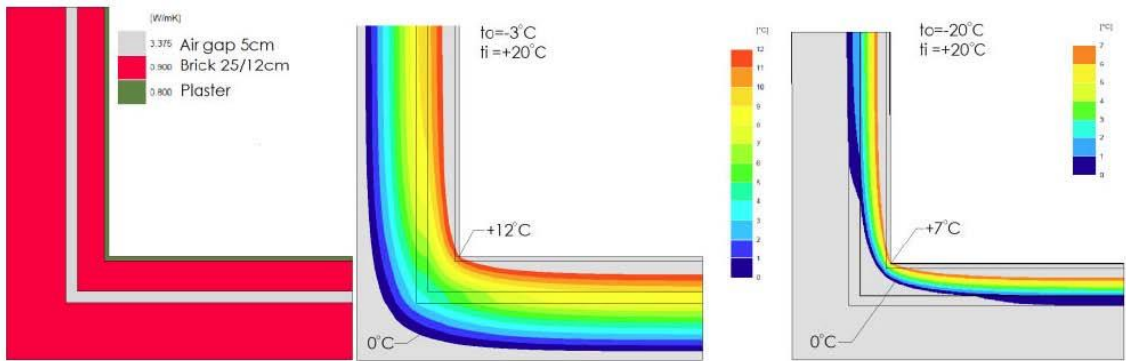
Figures 12 and 13 show the wall corner before and after the thermal modernization. The temperature

Figure 12: Model and calculation simulation of temperature isotherm distribution in an uninsulated corner of a building (outside temp. to -3°C and -20°C, internal temp. +20°C).

differences in the concave corner are $\Delta t = 5^\circ\text{C}$ to 8°C , which clearly speaks for the root of the thermomodernization works carried out.

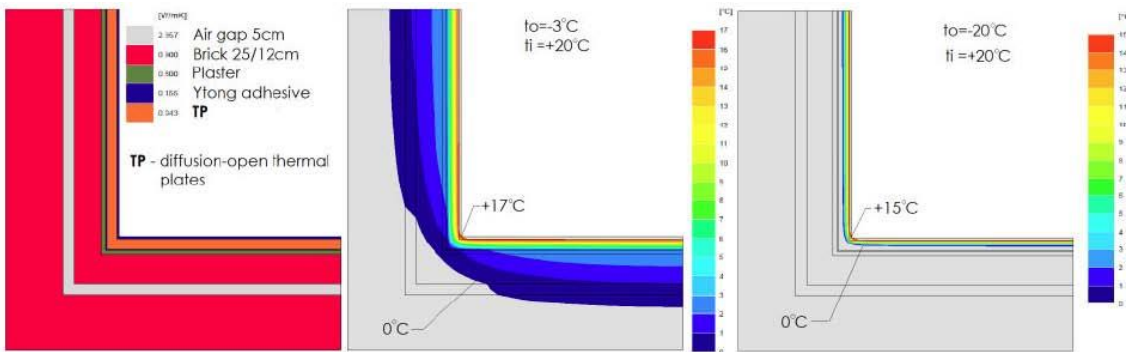
Figure 13: Model and calculation simulation of temperature isotherm distribution in the corner of a building after thermal insulation with 5 cm thick Multipor mineral plates (outside temp. to -3°C and -20°C, internal temp. +20°C).

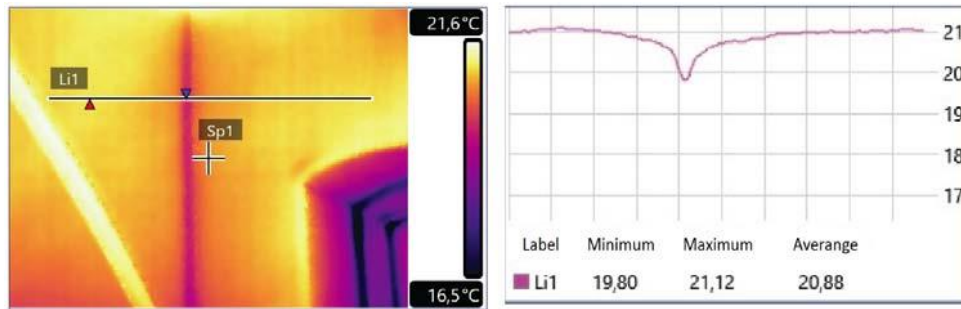
Figure 14: Calculation model of the floor walls (Figure 13) (outside temp. -3°C, internal temp. +21°C).

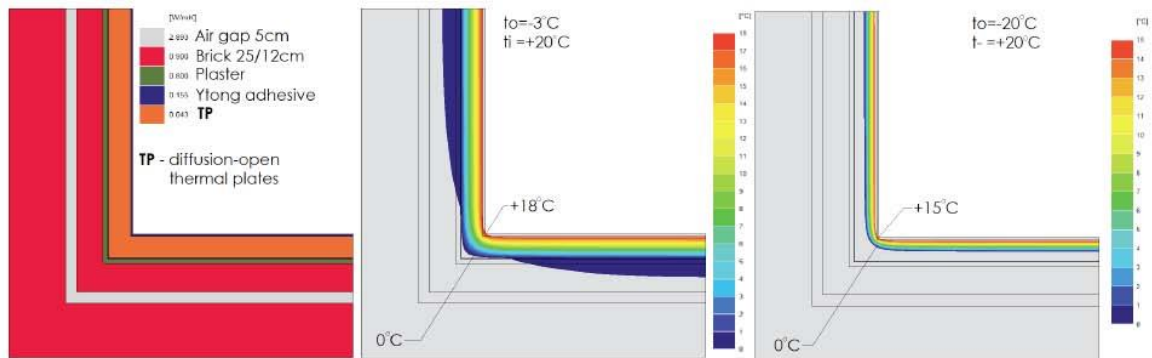
of external walls (with one exception - Figure 9, where a short layer of 10 cm boards was laid on a short section), that do not meet the requirements of applicable regulations (Table 1). Below the same partition was modelled with two times thicker layer of thermal insulation. This solution also does not meet the requirements of Polish and European standards set out in regulations and slightly improves the thermal condition of the corner. Although globally, on flat wall fragments, it has a higher surface temperature, by approx. 2.5°C .

Figure 15: Model and calculation simulation of temperature isotherm distribution in the corner of a building after thermal insulation with 10 cm thick Multipor mineral plates (outside temp. t_o -3°C and -20°C, internal temp. t_i +20°C).

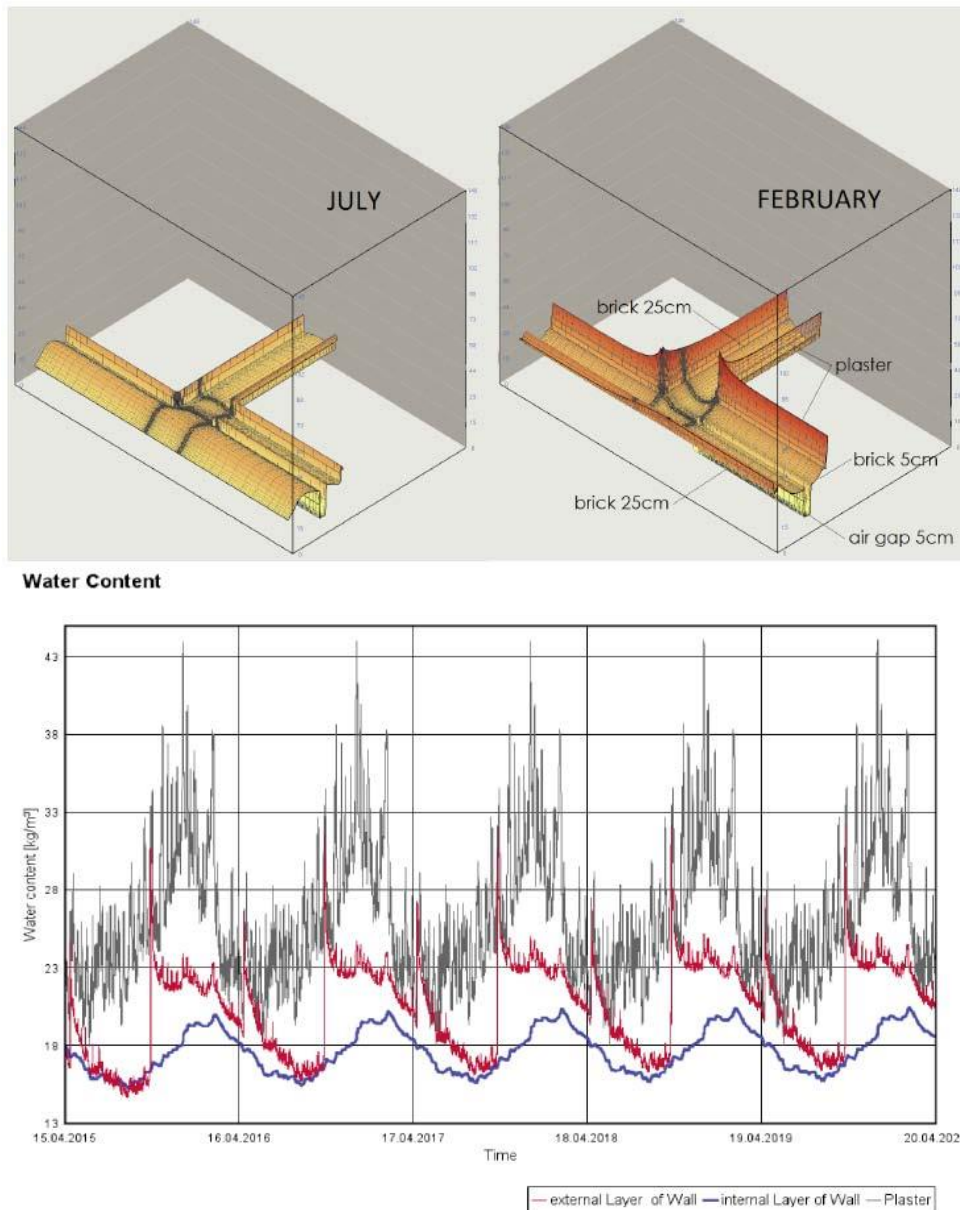
Figure 16: Diagram of moisture distribution in the partition (Figure 8) over a period of 5 years, in w kg/m^3 .

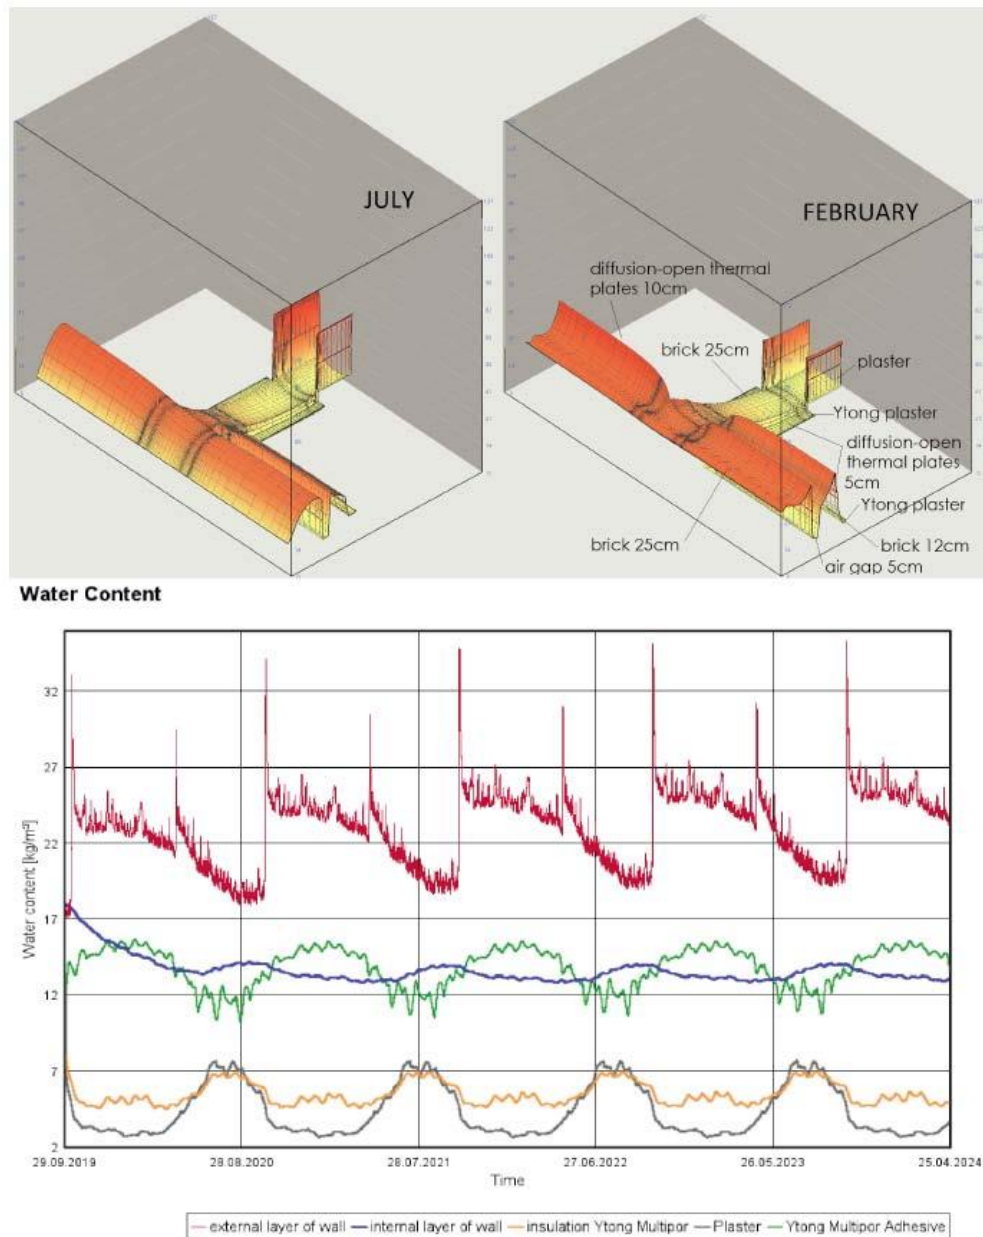
Figure 17: Diagram of moisture distribution in a partition (Figure 9) over a period of 5 years, w kg/m³.

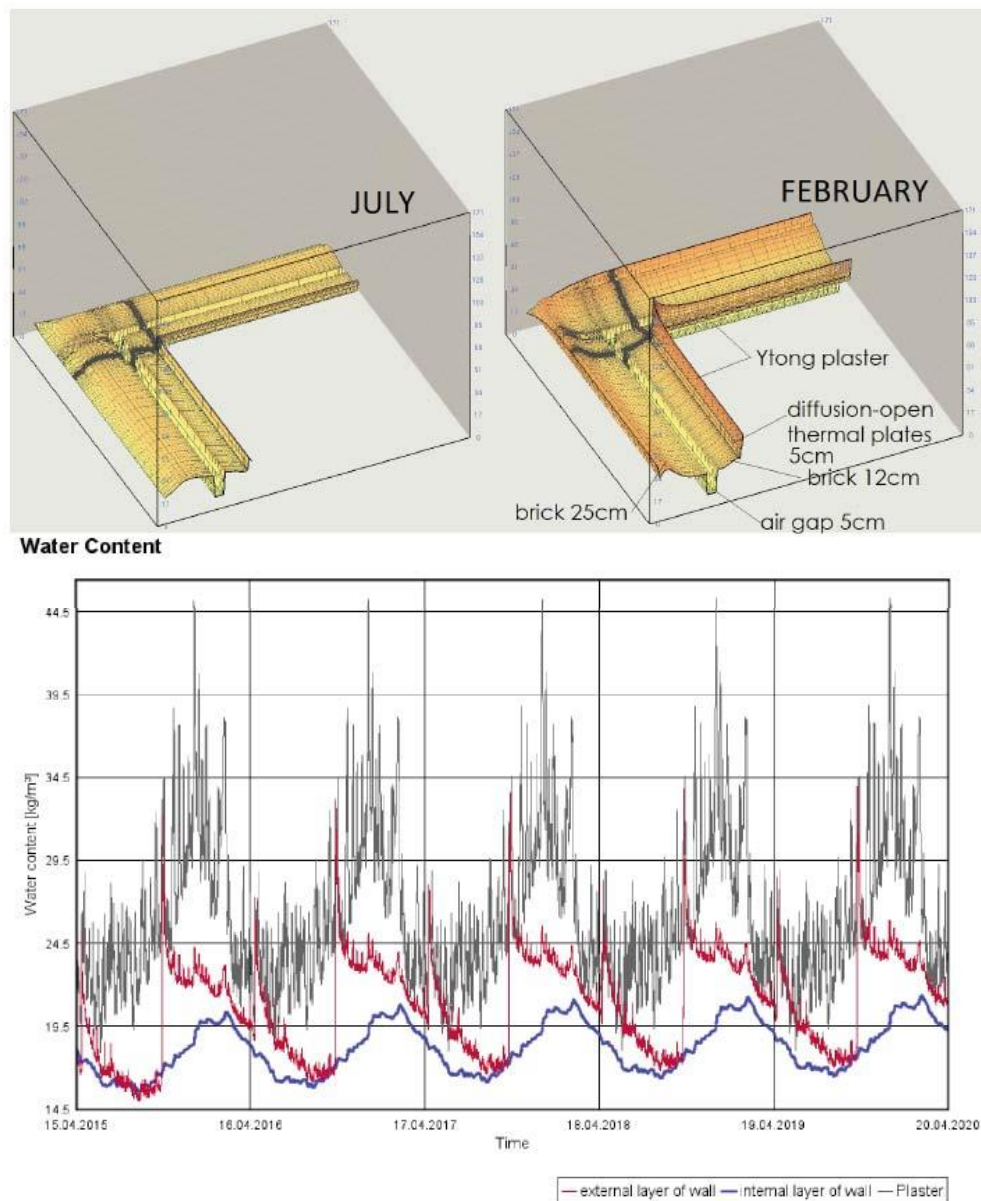
Figure 18: Diagram of moisture distribution in the partition (Figure 12) over a period of 5 years, w kg/m³.

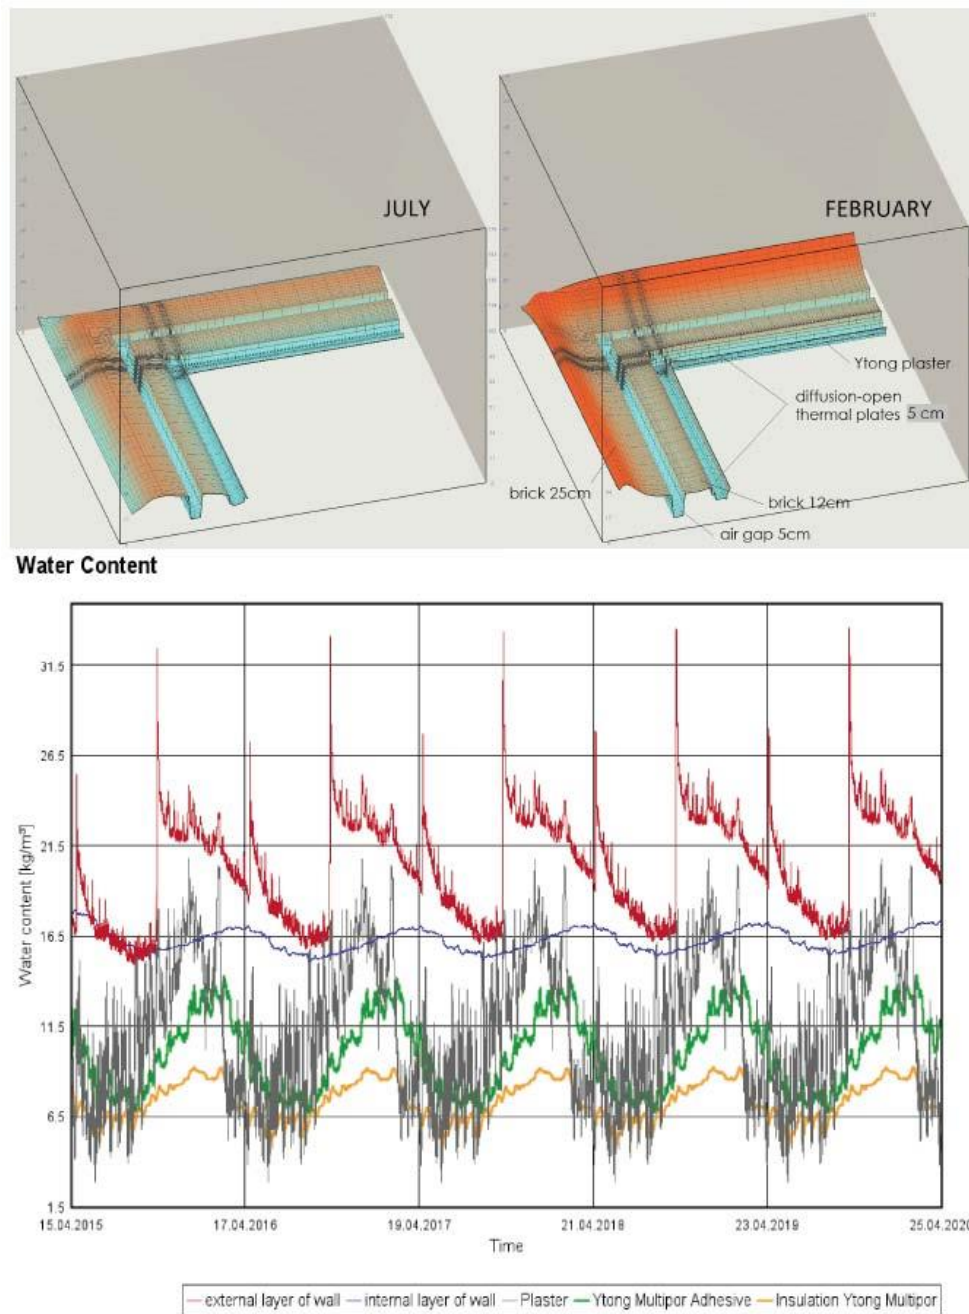
Figure 19: Diagram of moisture distribution in the partition (Figure 13) over a period of 5 years, w kg/m³.

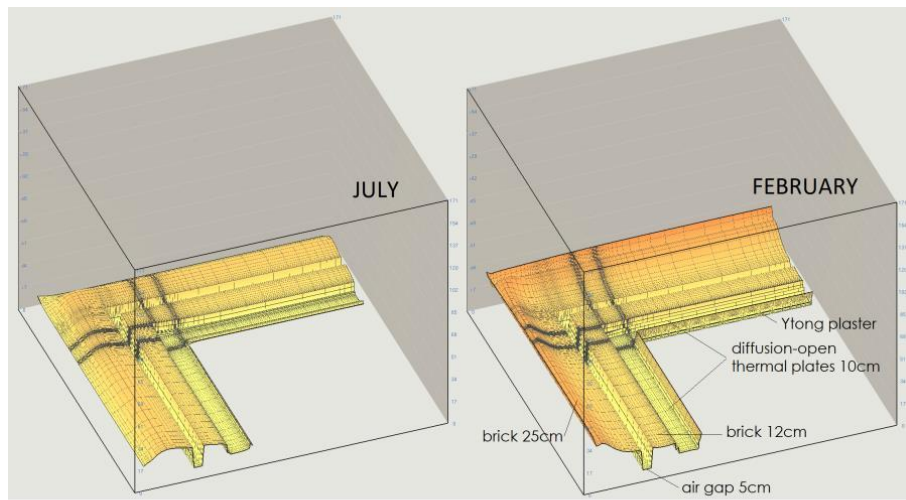
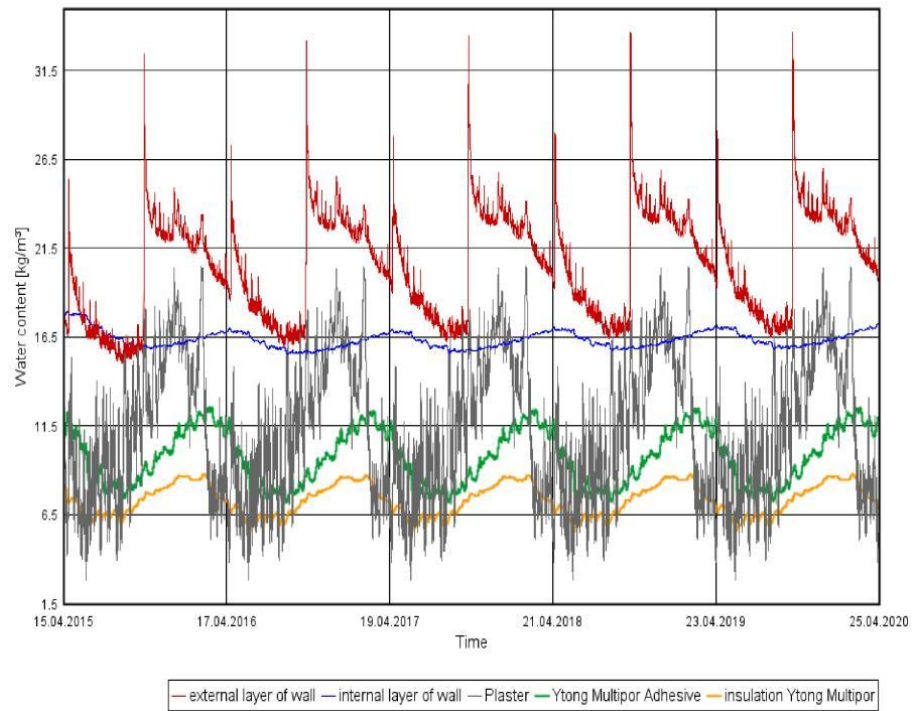
Figure 20: Diagram of moisture distribution in the partition (Figure 15) over a period of 5 years, w kg/m³.
